MISCELLANEOUS PAPER S-77-9

PRELIMINARY INVESTIGATION OF GENERAL-PURPOSE MAT/PANEL MATERIALS

Soils and Pavements Laboratory
U. S. Army Engineer Waterways Experiment Station
P. O. Box 631, Vicksburg, Miss. 39180

May 1977

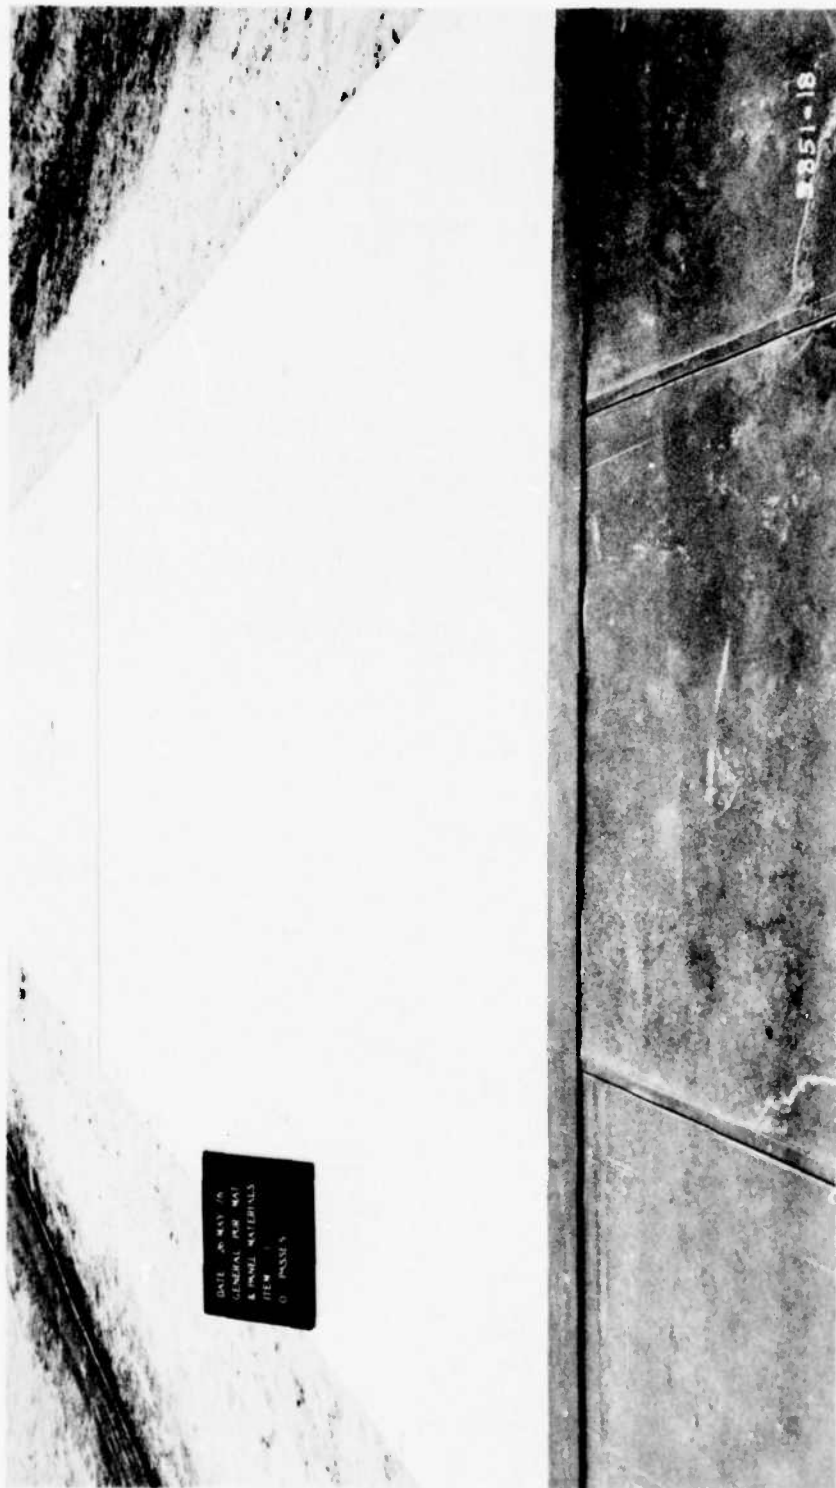
Photo 1. Item 1, test section 1; Wells extruded aluminum prior to traffic

15. A general view of the Wells panels prior to traffic is shown in Photo 1. After 200 passes of the test vehicle (Photo 2), the panels were still relatively flat and no distortion was observed. There was some lateral shifting of the panels with respect to the test section and to each other. The cross-section and profile data (Plate 3) revealed that the subgrade was consolidating and/or migrating beneath the panels. As traffic was continued, the shifting of the panels continued and several times traffic was temporarily stopped so that the panels could be realigned. The panels remained relatively smooth with no rutting or dishing after 2000 passes (Photo 3). Traffic was discontinued after 3000 passes (Photo 4). There was no evidence of panel failure nor distortion although the cross-section and profile data had changed to a maximum of 1.3 in. and 1.4 in., respectively, in 3000 passes (Plate 3). Data taken at the transition between the approach mat and the test items were not used. During the traffic, some sand particles had entered the connectors of the panels and this sand under the action of the test vehicle had caused some abrasive wear on the connectors. However, this did not cause any detrimental effects on the panels in that their overall condition was very good and the panels were capable of sustaining additional traffic.

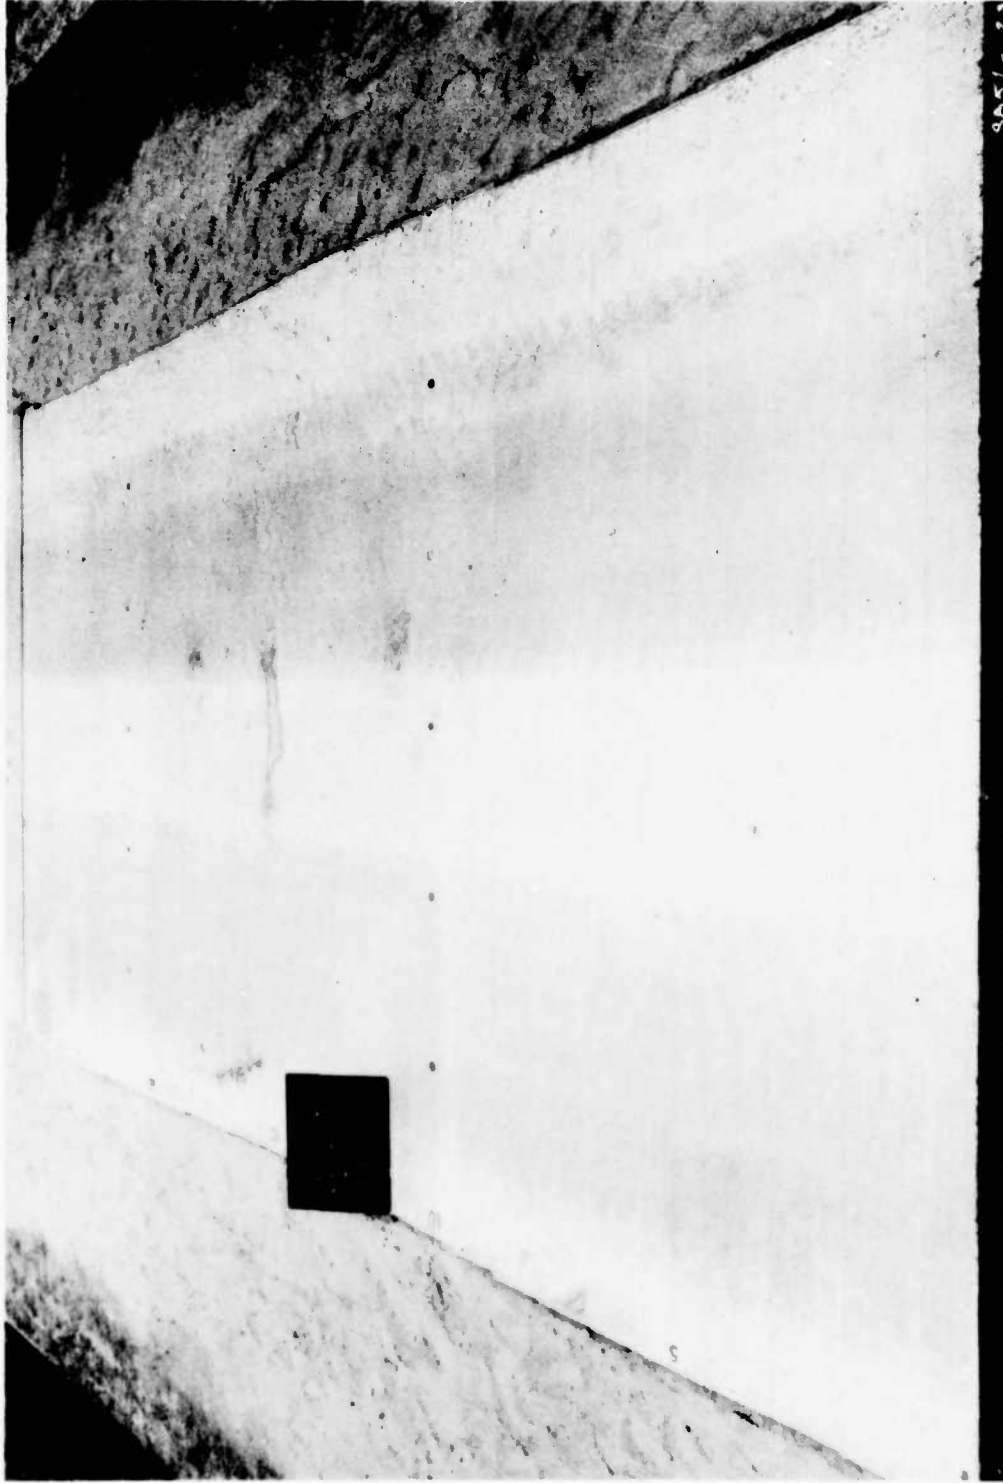
Photo 2. Wells extruded aluminum after 200 passes

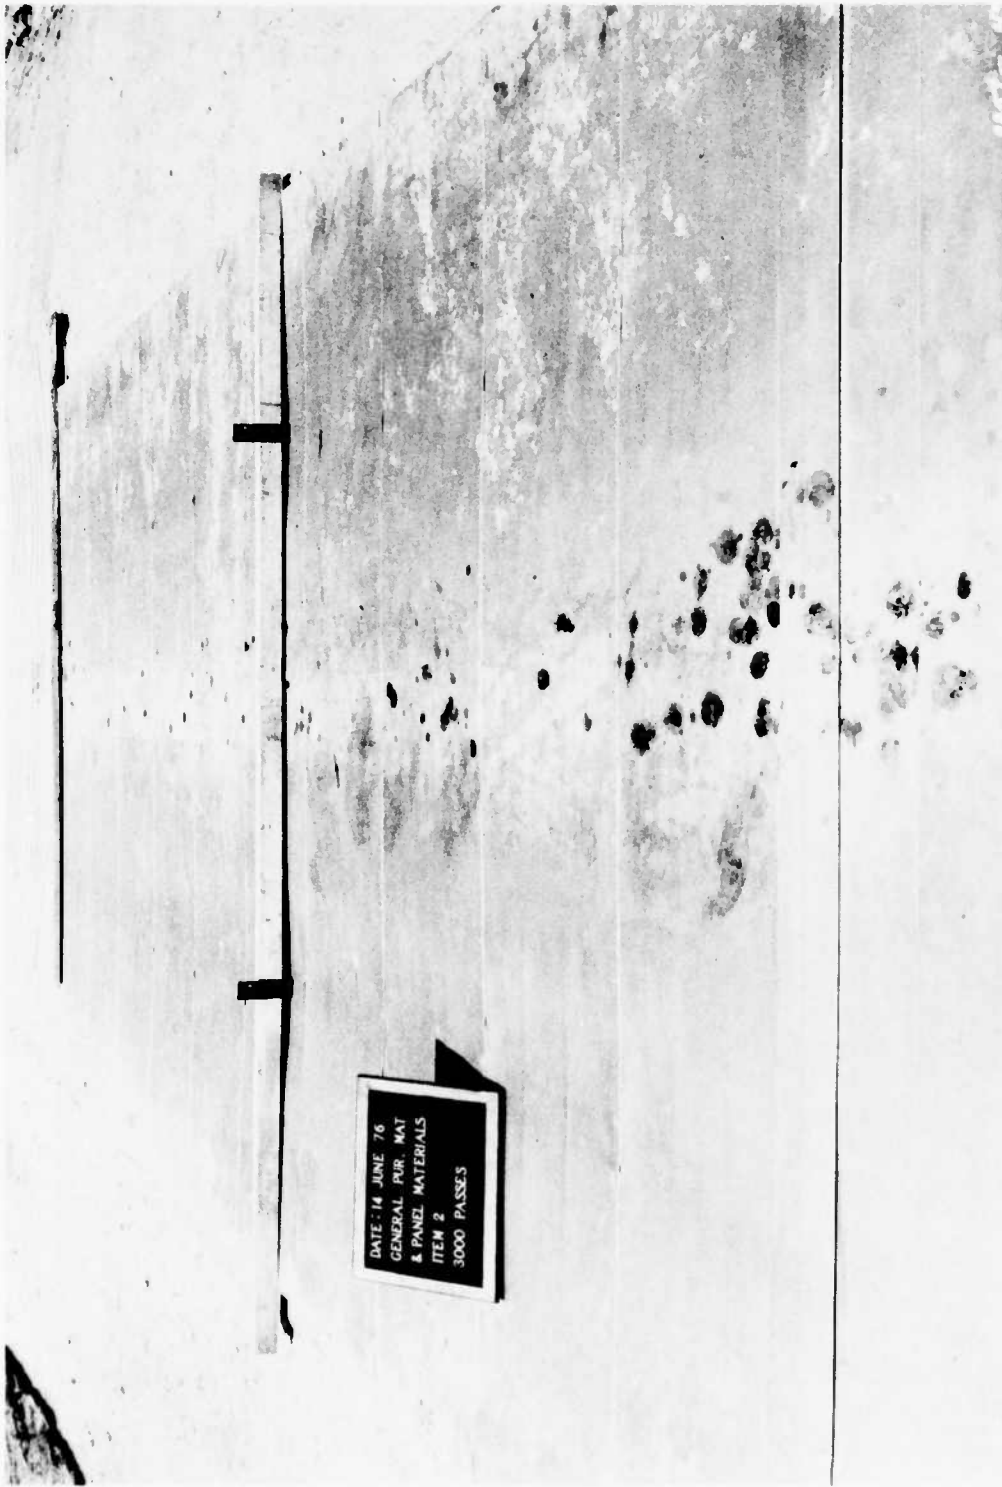
Photo 9. Taber extruded aluminum after 3000 passes

22. The Taber panels sustained 3000 passes of the test vehicle; however, internal deterioration of the panels was observed at 677 passes.

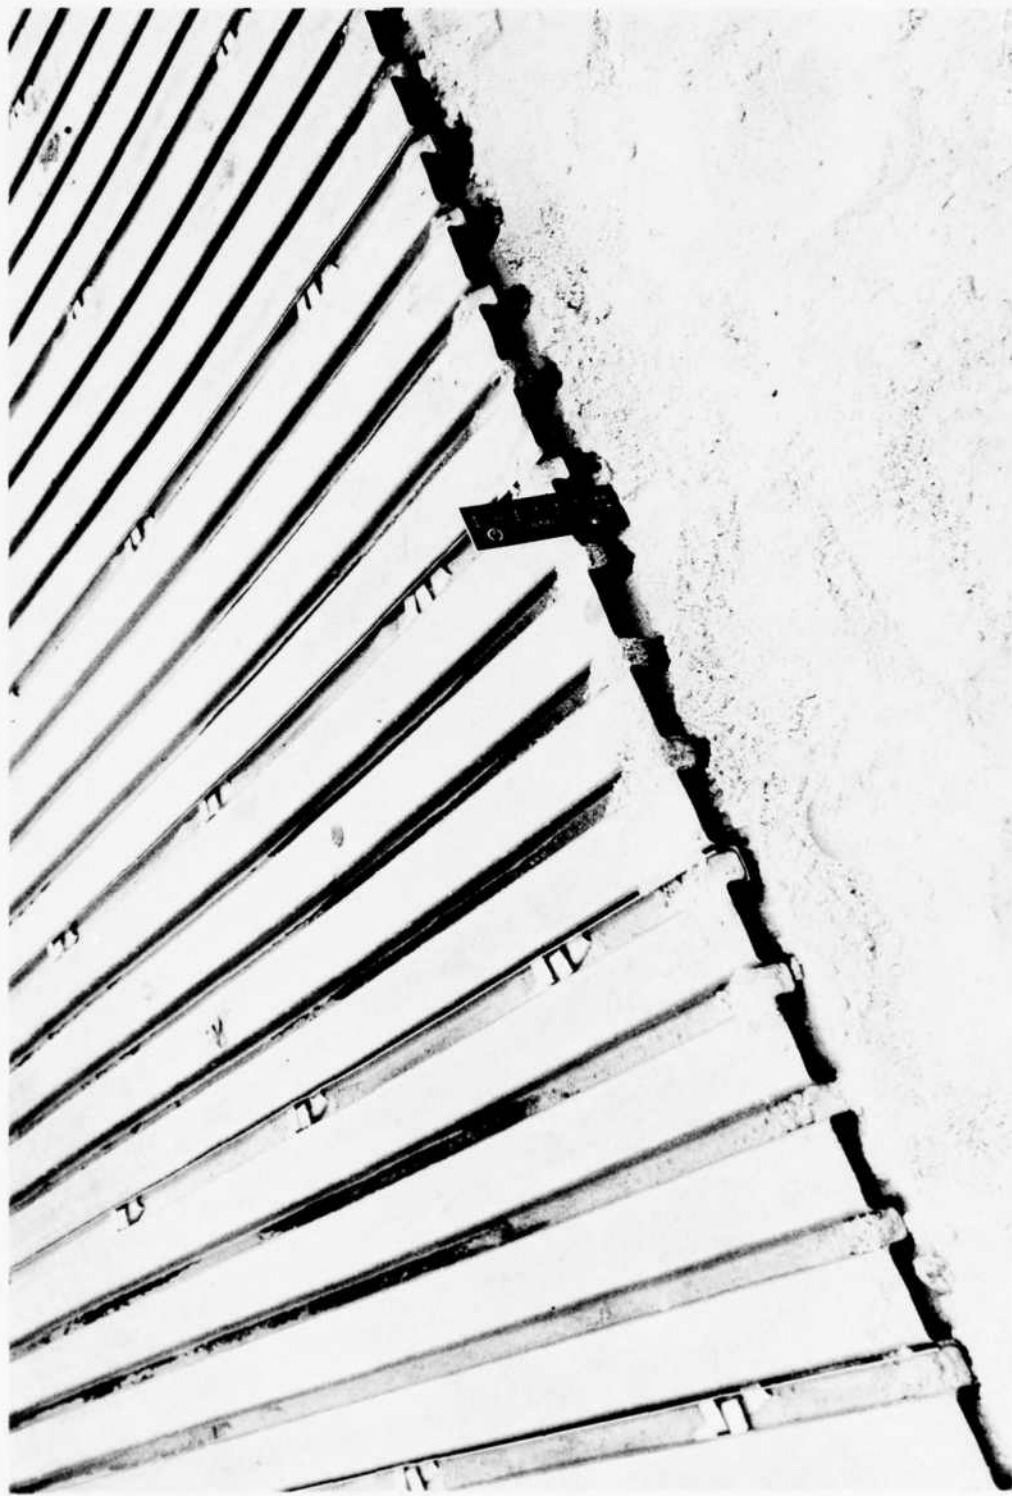
Photo 13. South edge of Fletcher panels after 200 passes

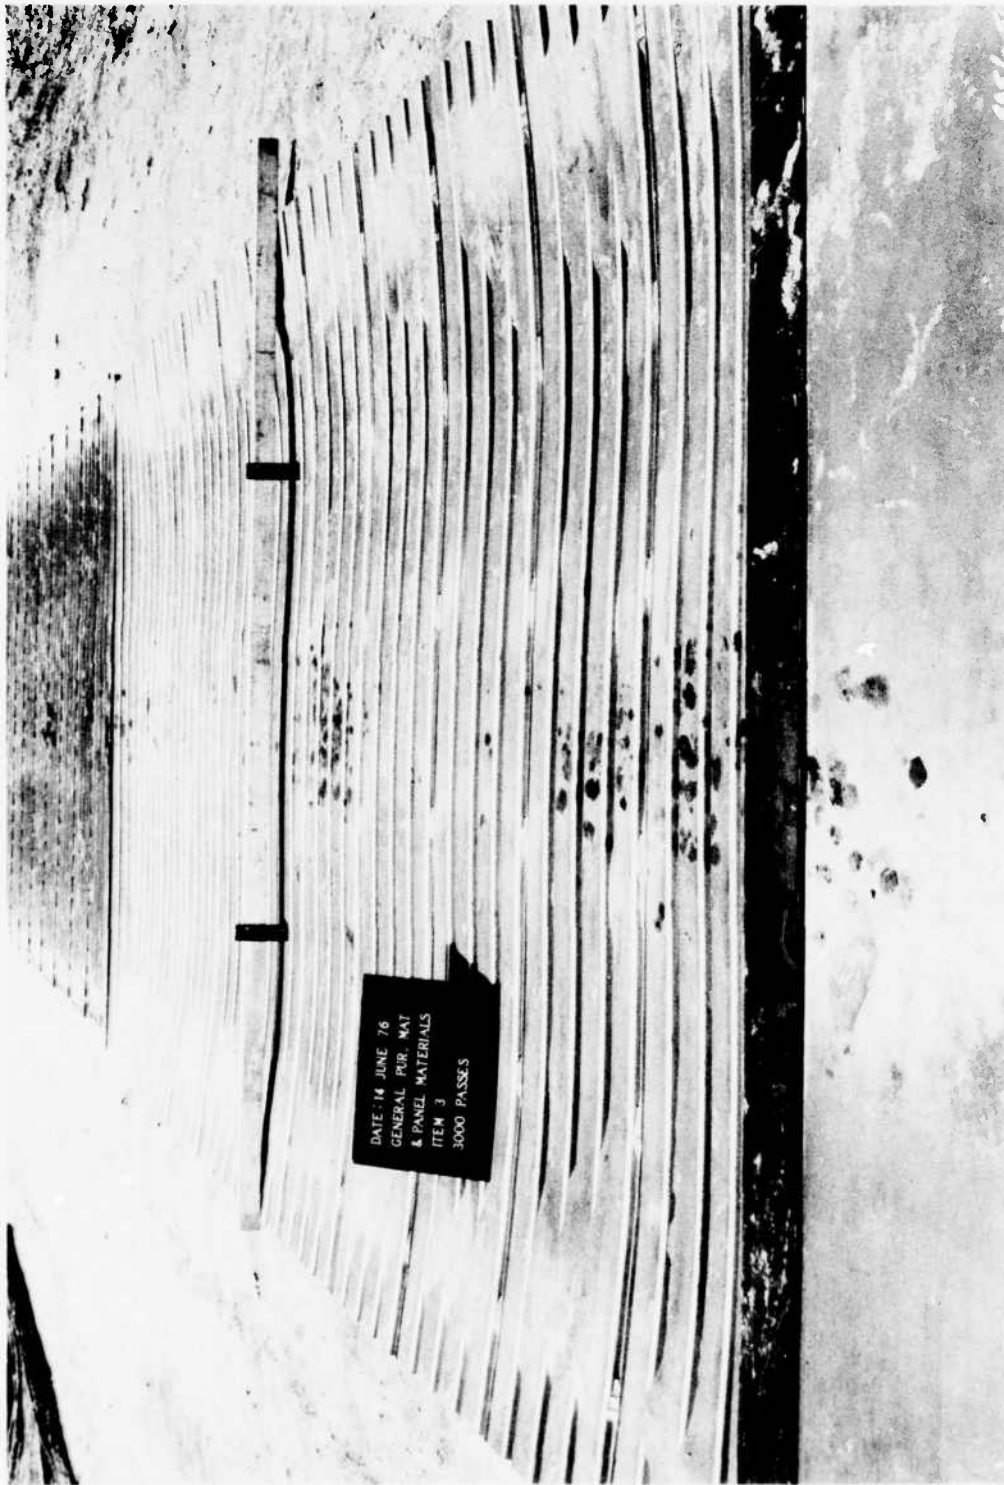
Photo 17. Fletcher formed panels after 3000 passes

27. The performance of the Fletcher panels under traffic was not as good as that of several of the other materials. The individual panels were longitudinally dished as much as 3-5/8 in. at the completion of 3000 passes. The cross-section and profile data (Plate 6) confirm not only longitudinal dishing but transverse dishing. After 3000 passes, a tire hazard was present due to the split in panel 43 and adjacent panel 44 which originated at the spring clip holes in these panels. In the laboratory tests (Tables 2 and 3), the values obtained for the buckling and rigidity tests ranked fifth and seventh, respectively, in a total of nine different materials subjected to these tests. The value for the crushing test was the lowest obtained in a total of ten materials subjected to this test. Since the Fletcher panel did not perform in the traffic tests without distortion and panel splitting and since the laboratory strength values were lower than those for several other materials investigated, no further evaluation of these panels in their present form is recommended.

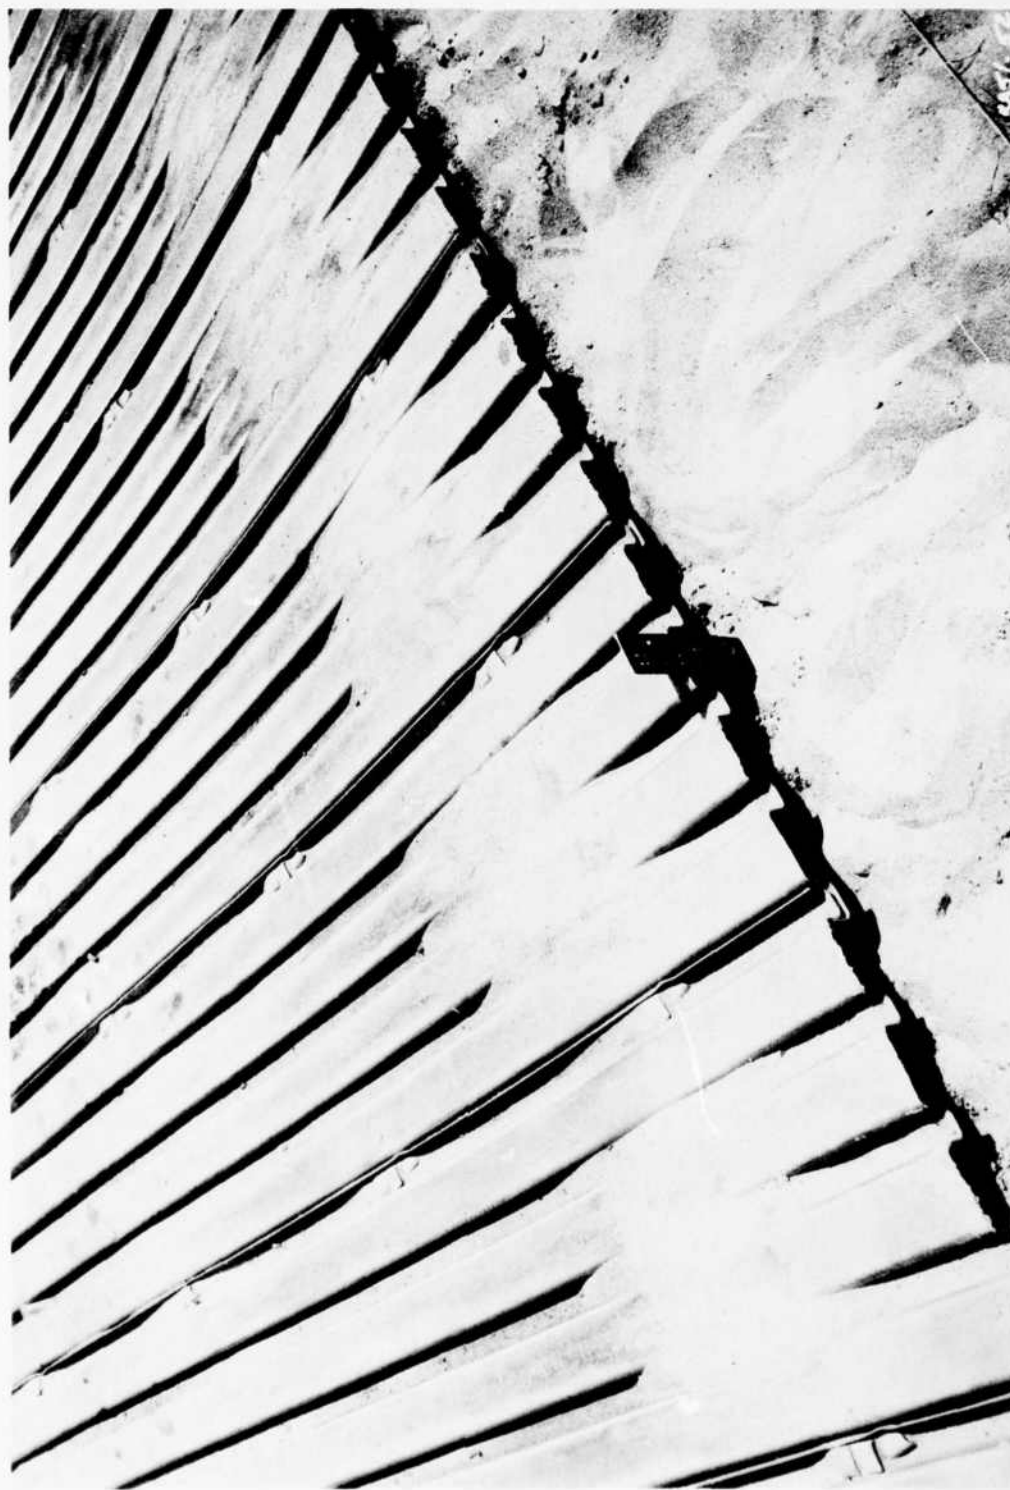
Photo 18. South edge of Fletcher panels after 3000 passes

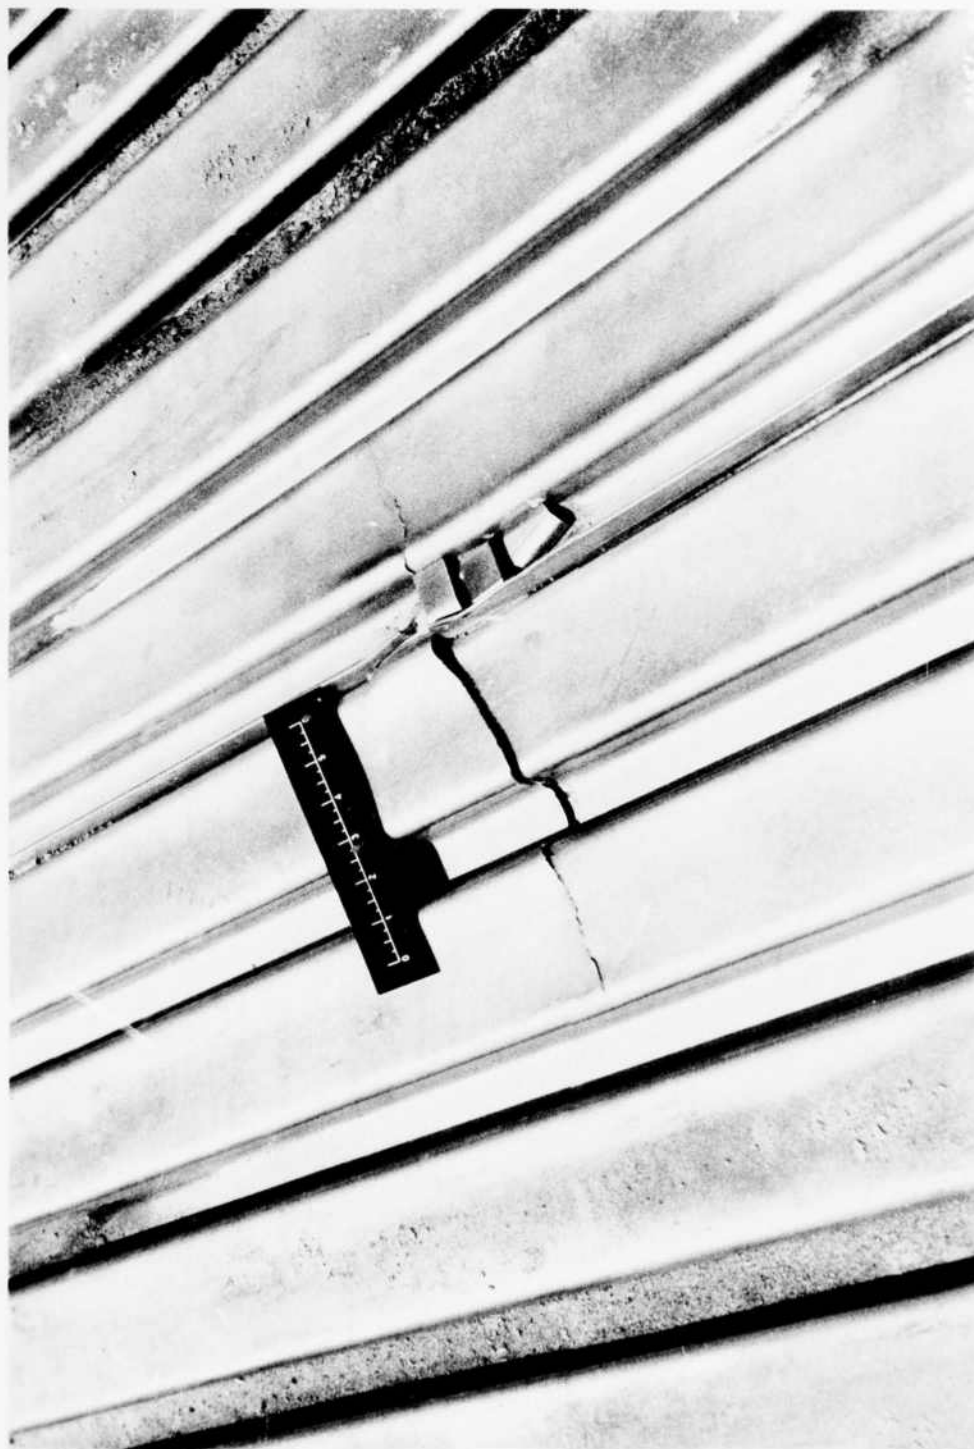
Photo 19. Split in Fletcher panel 43 after 3000 passes

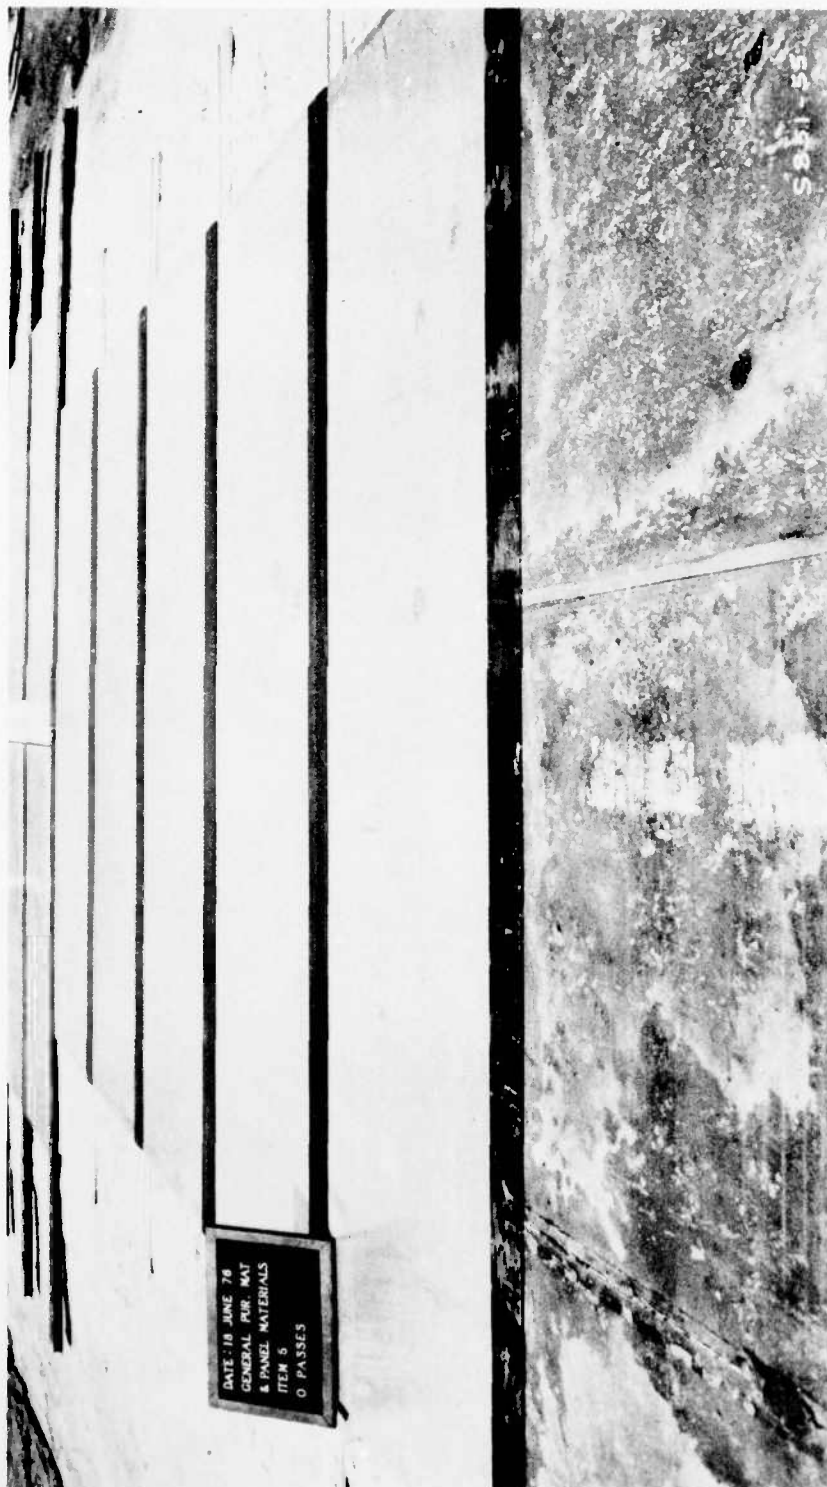
Photo 23. Item 5, test section 2; M. C. Gill sandwich panels prior to traffic

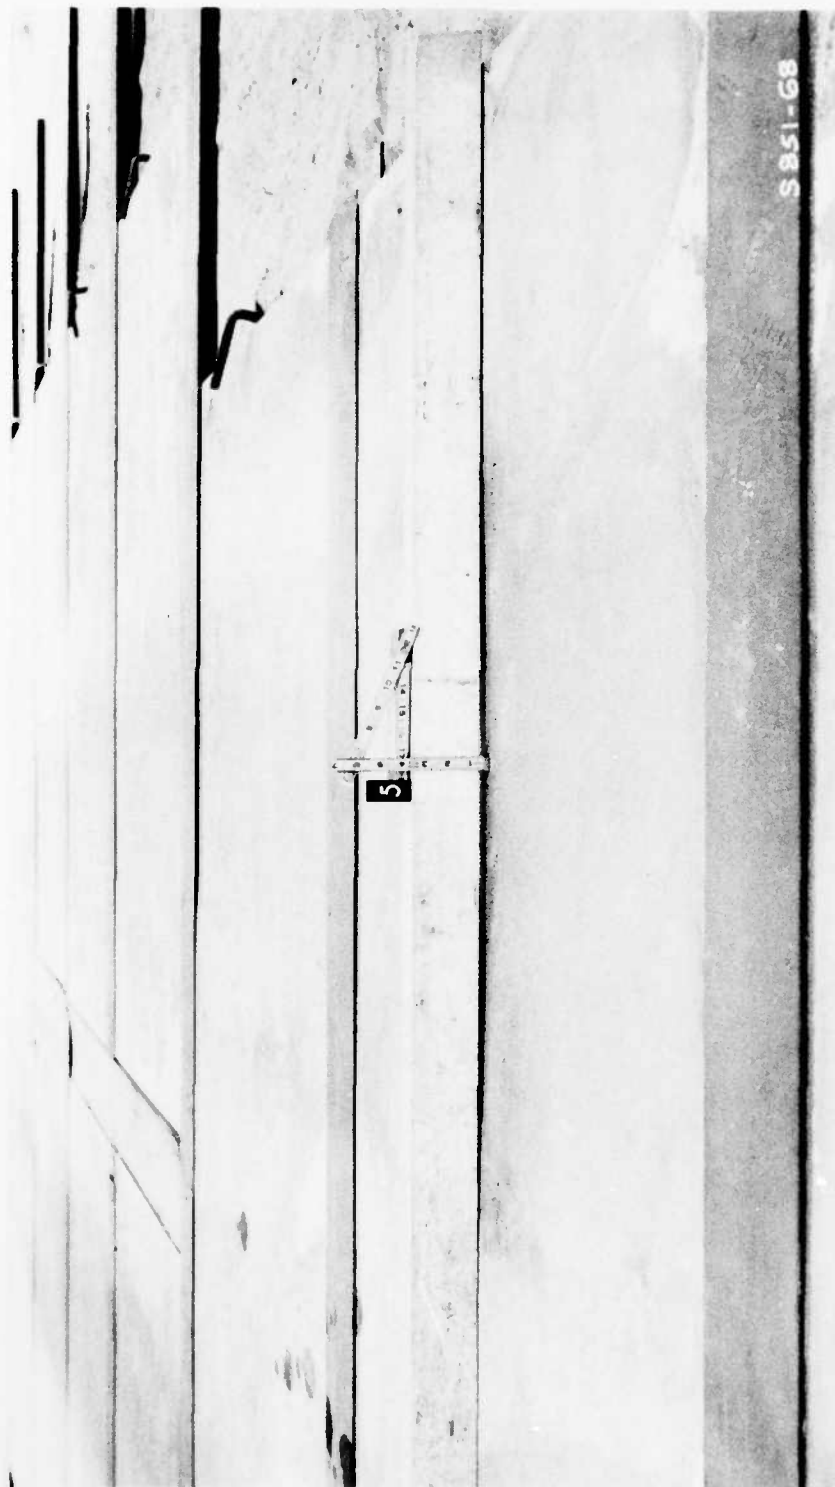
Photo 24. M. C. Gill panel 3 deformed 1/4 in. at 1000 passes

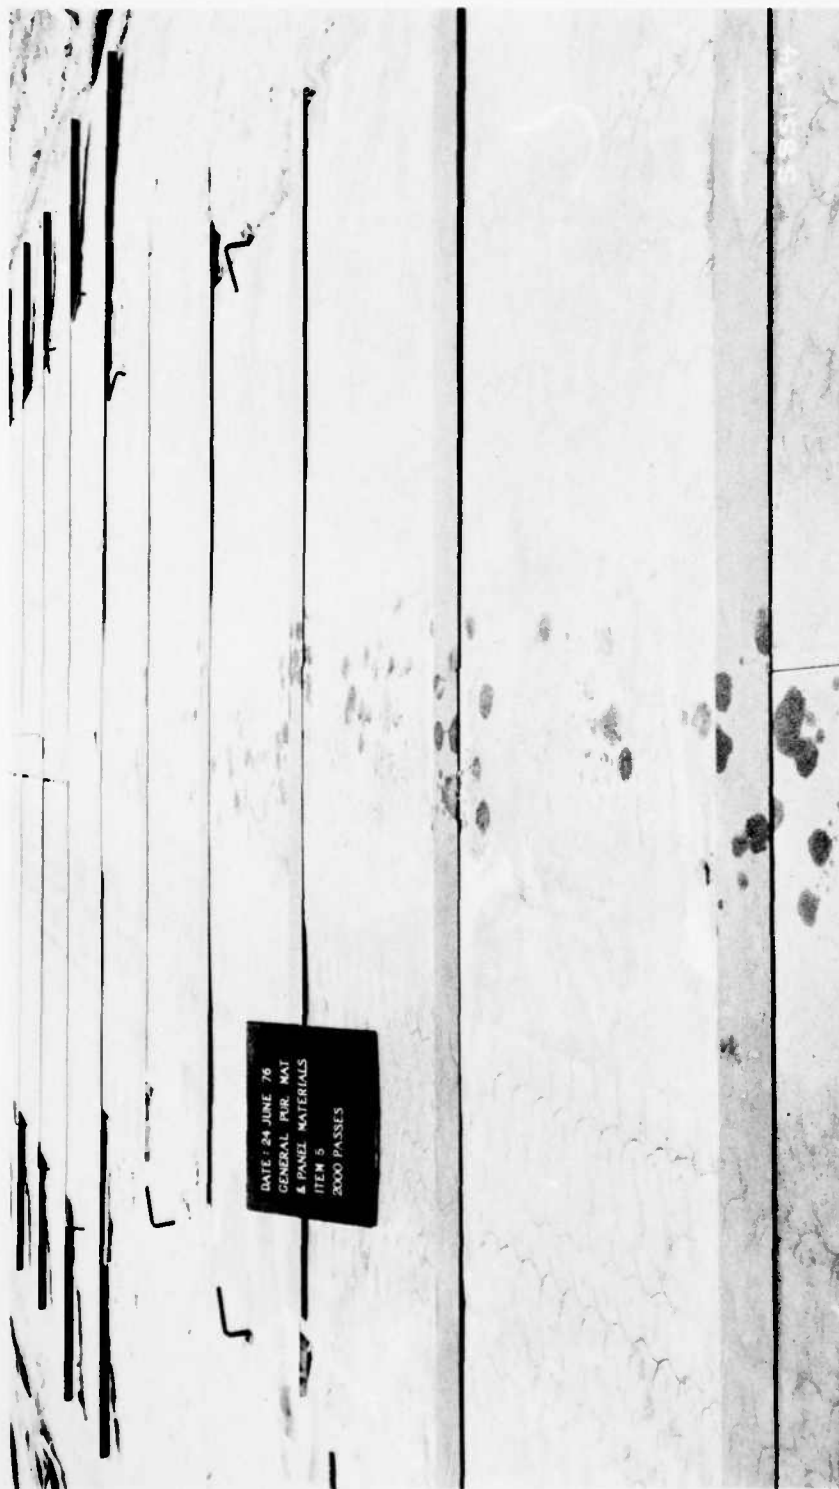
Photo 25. General view of failed M. C. Gill mat section at 2000 passes

38. The M. C. Gill panels started disbonding between 300 and 500 passes and progressively disbanded and became rougher with additional traffic. Breaks were noted in the top skin at 1600 passes and the item was considered failed at 2000 passes. At 1.9 lb per sq ft, the panels were the third lightest tested. The M. C. Gill panel was among the top four in crushing strength, but ranked last in both buckling and rigidity loading.

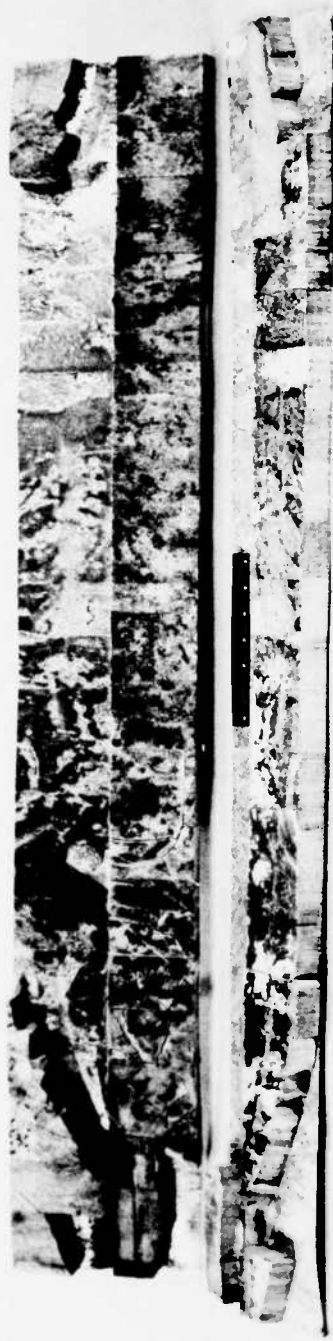
Photo 26. Cross section of failed M. C. Gill balsa wood panel

36. At 1600 passes, panel 1 had a 1-in. break in the south wheel path which progressed to 4-1/2 in. at 1720 passes. At 1900 passes, panel 4 had a 2-in.-long break. At 2000 passes, the item was considered failed as disbondment was extensive in both wheel paths. The section is shown at the completion of traffic (2000 passes) in Photo 25. Panels 1, 4, and 5 had top skin breaks, and panels 1, 3, and 4 had bottom skin breaks. The maximum length of breaks on the top and bottom was 5-3/4 in. Panel 4 was dissected to inspect the internal

core failure and adhesive failures (see Photo 26). Only about 5 percent of the bond of the specimen in Photo 26 had to be forced apart by hand as the other 95 percent had failed during the traffic test.

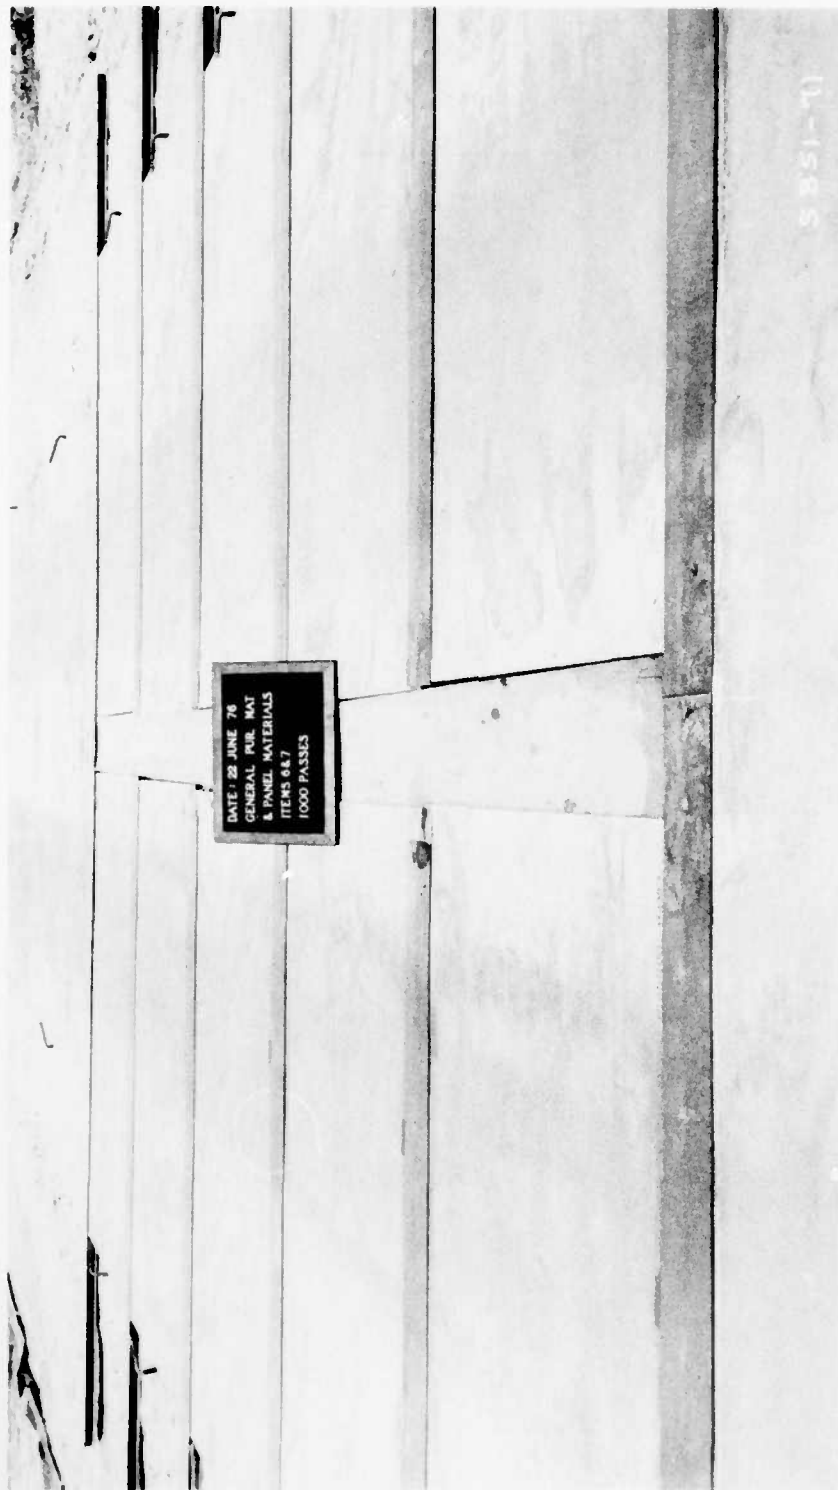
Photo 28. Kaiser panels at 1000 passes; no failures (3.0-lb panels at left and 2.5-lb panels at right)

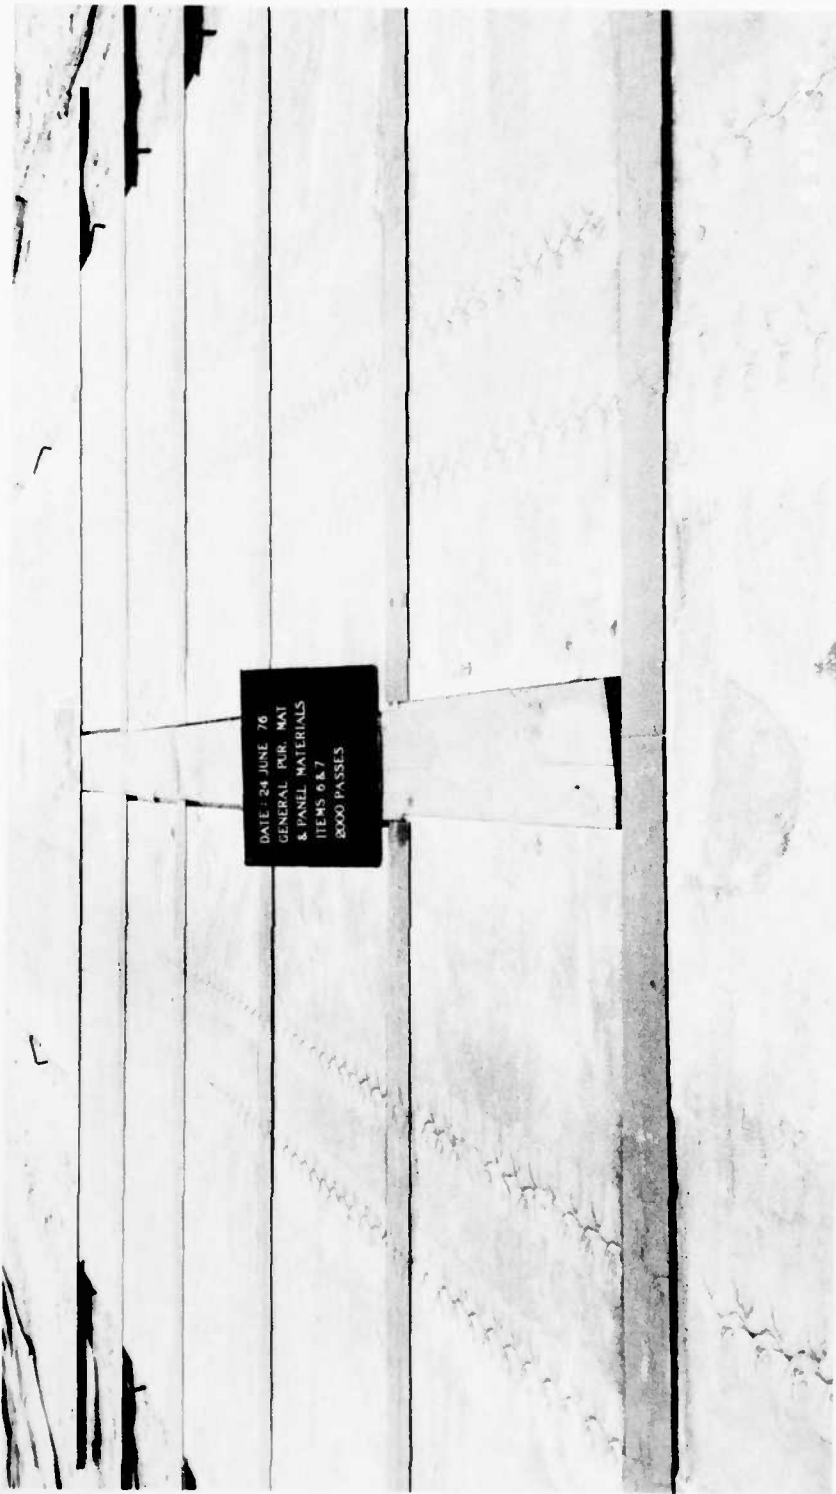
Photo 29. Kaiser panels in good condition at 2000 passes
(left, 3.0-lb panels; and right, 2.5-lb panels)

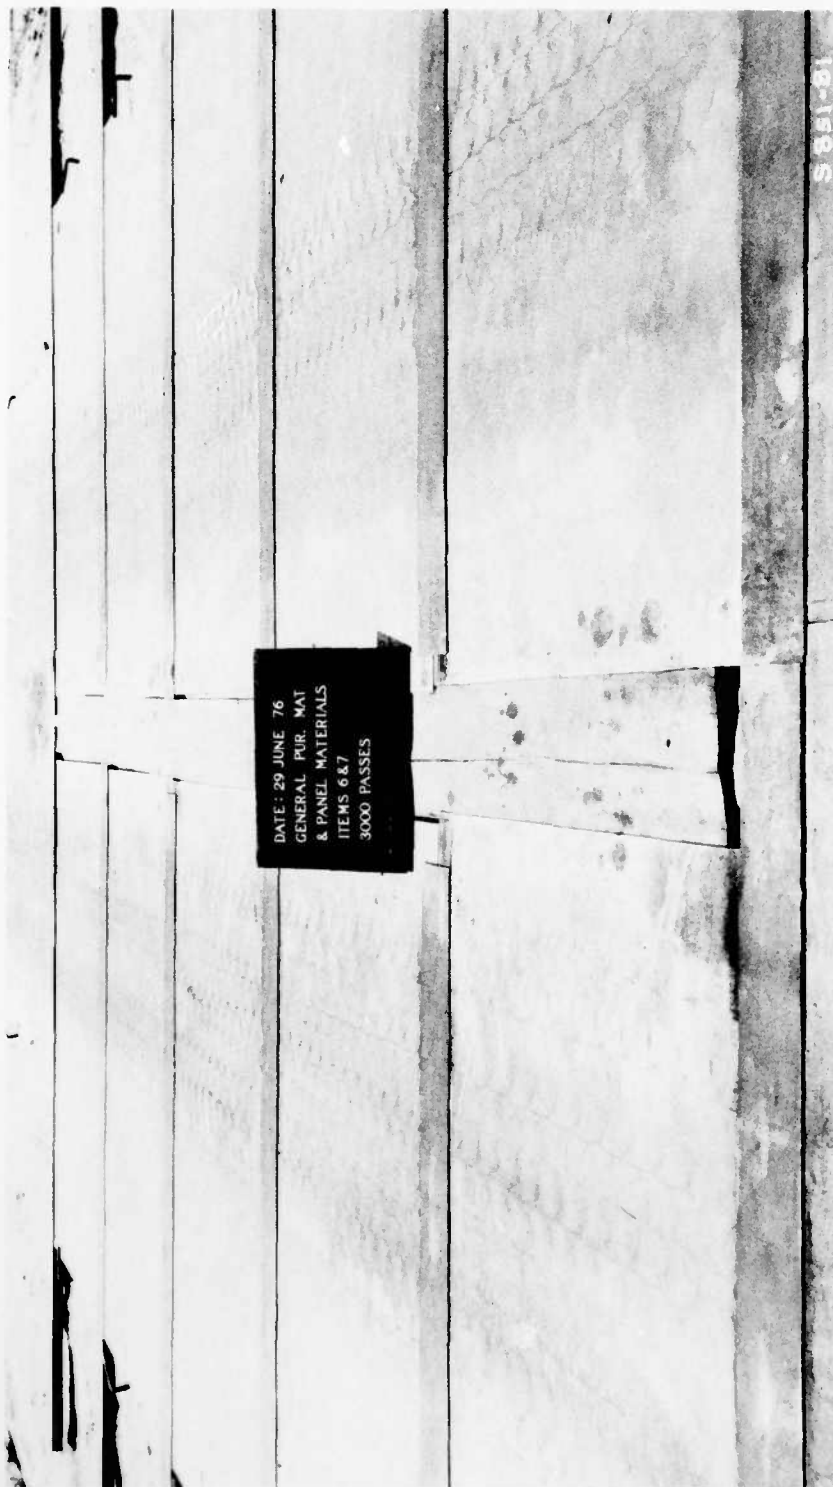
Photo 30. Kaiser panels at 3000 passes (end of traffic test);
no failures (3.0-lb panels at left and 2.5-lb panels at right)

49. The 3.0- and 2.5-lb Kaiser panels both withstood 3000 passes of the test vehicle. Both were in excellent condition at the end of the traffic test with no sign of stress or core bond degradation. The panels were within ± 0.020 in. of being flat when measured with a 4-ft straightedge. In the buckling test, the 3.0- and 2.5-lb panels were rated one and two, respectively, relative to the nine types of panels tested. In the rigidity test, the 3.0-lb panels were rated fourth and the 2.5-lb panels were rated sixth. The first and third rated materials in the rigidity test, M8A1 and Alcoa, were both overweight at 7.5 and 3.5 lb per sq ft, respectively. The fifth ranked Taber panel is 17 percent heavier than the light Kaiser panel (2.8 and 2.2 lb per sq ft, respectively) and produced a rigidity value only 10 percent greater than that of the lighter Kaiser panel.

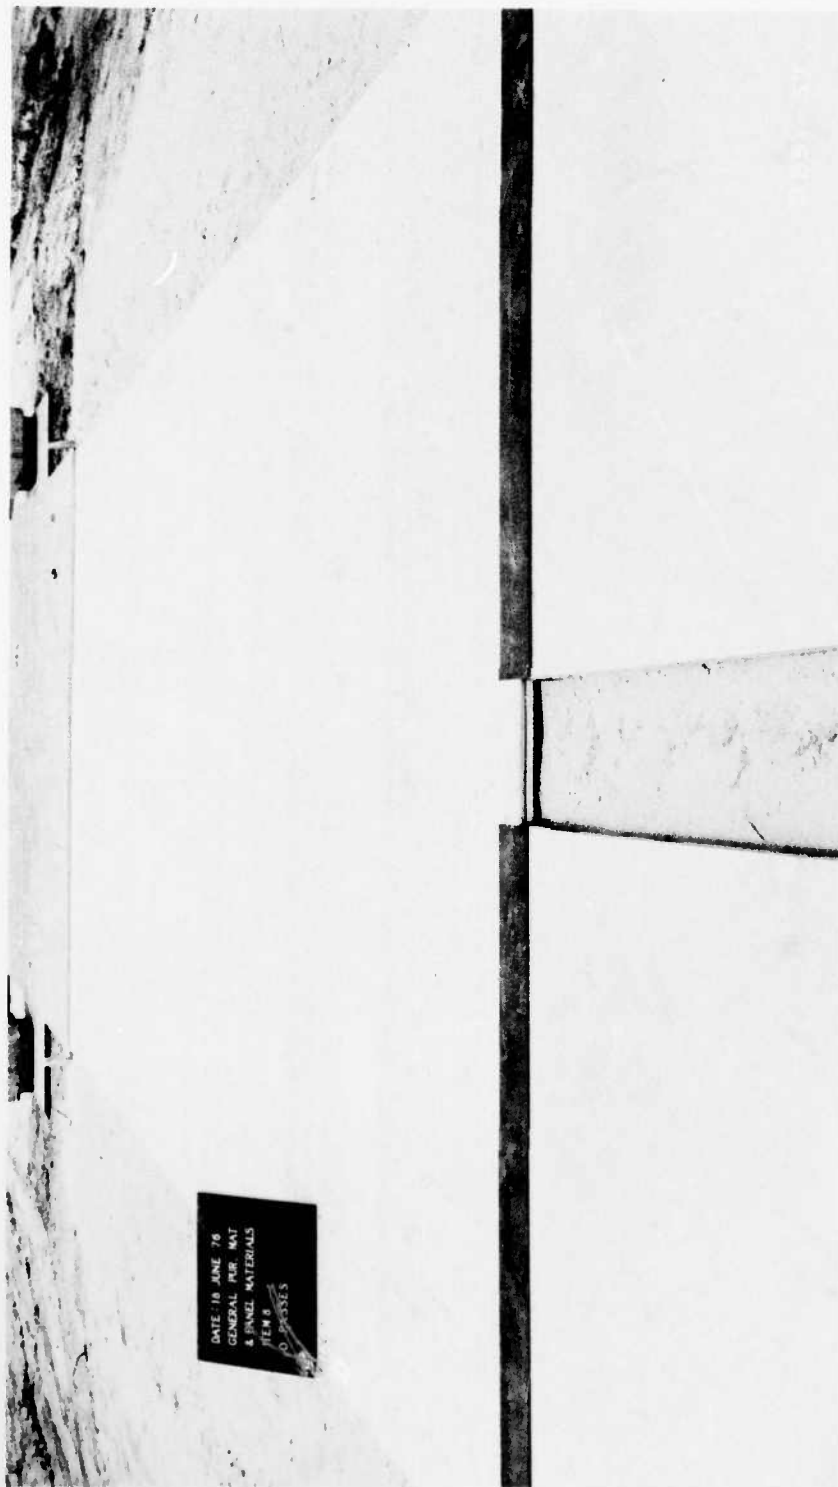
Photo 31. Item 8, test section 2; Alcoa panels prior to traffic

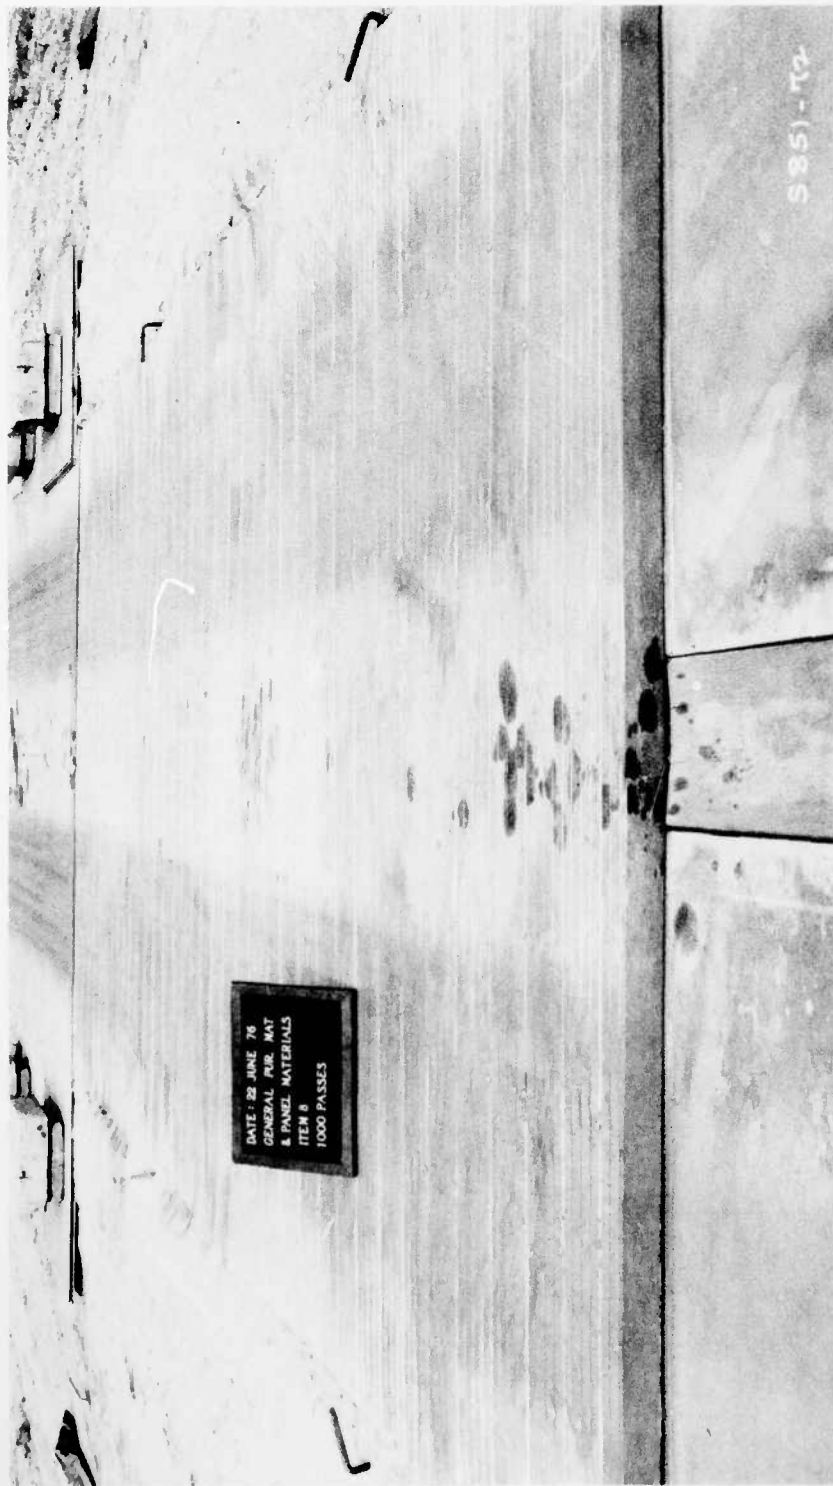
Photo 32. Alcoa panels at 1000 passes; no failures
